CONNECTICUT RIVER BASIN
HANOVER, NEW HAMPSHIRE

ENFIELD RESERVOIR DAM
NH 00354

PHASE I INSPECTION REPORT
NATIONAL DAM INSPECTION PROGRAM

APRIL 1979

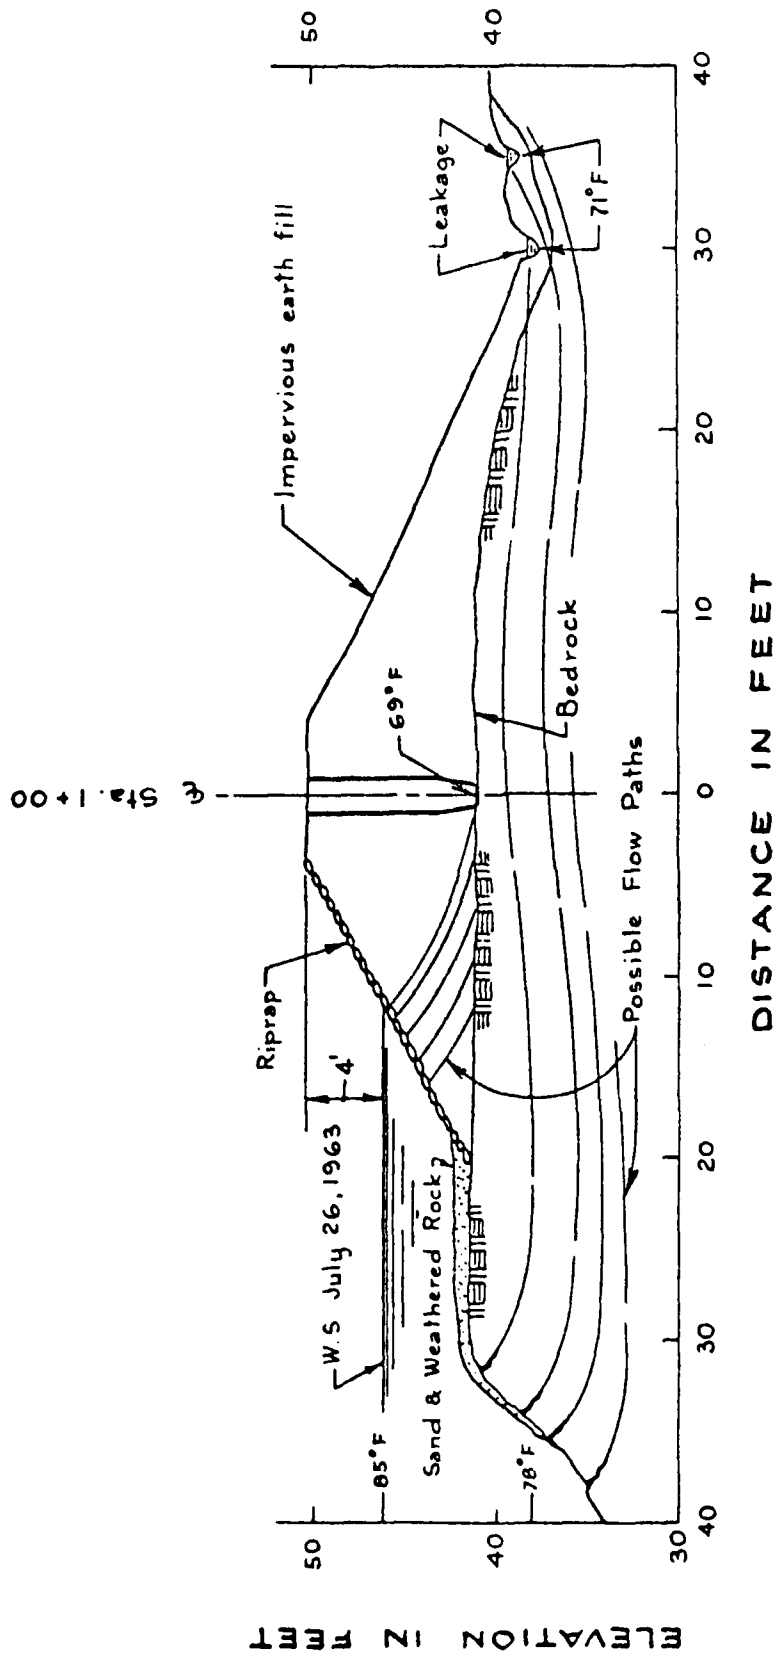
FIG.2 TEST PIT NO.1 - JULY 26, 1963

Over a period of years water has appeared on the downstream toe of the dam adjacent to the deflection point, and the question has arisen as to whether the source of this water was from leakage through the dam or from springs. On July 1, 1963, we made three determinations of the flow issuing from the downstream toe of the dam adjacent to the deflection point and estimated the leakage to be about 170 gpm (gallons per minute). Another leak at the west end of the concrete spillway was observed to be about 20 gpm. The total leakage through the dam therefore was about 190 gpm with the reservoir water level less than 1 ft below the top of the flashboards (almost 4 ft below the top of the dam). On July 26, 1963, Test Pit No. 1 was dug along the axis of the dam at Sta. 1+00 (5 ft SW of the deflection point). The water level in the reservoir was 4 ft below the top of the dam. Examinations of the bedrock at this location revealed it to be sound while examinations of the embankment soils revealed them to be relatively impervious - sandy silt, silty sand, some clay and fine gravel. The small amount of inflow to the pit (less than 0.1 gpm) served to indicate this area to be trouble free. The contention that the water appearing on the downstream toe of the dam was spring water was dispelled by a study of water temperatures at various depths in the reservoir as well as in the pit and on the downstream toe. Fig. 2 shows the findings of Test Pit No. 1 and the water temperatures observed. The variance of flow with reservoir stage also seemed to discount the spring theory. Subsequent determinations on two later dates indicated that the rate of flow varied with the water level of the reservoir; as the water level decreased so did the rate of flow.

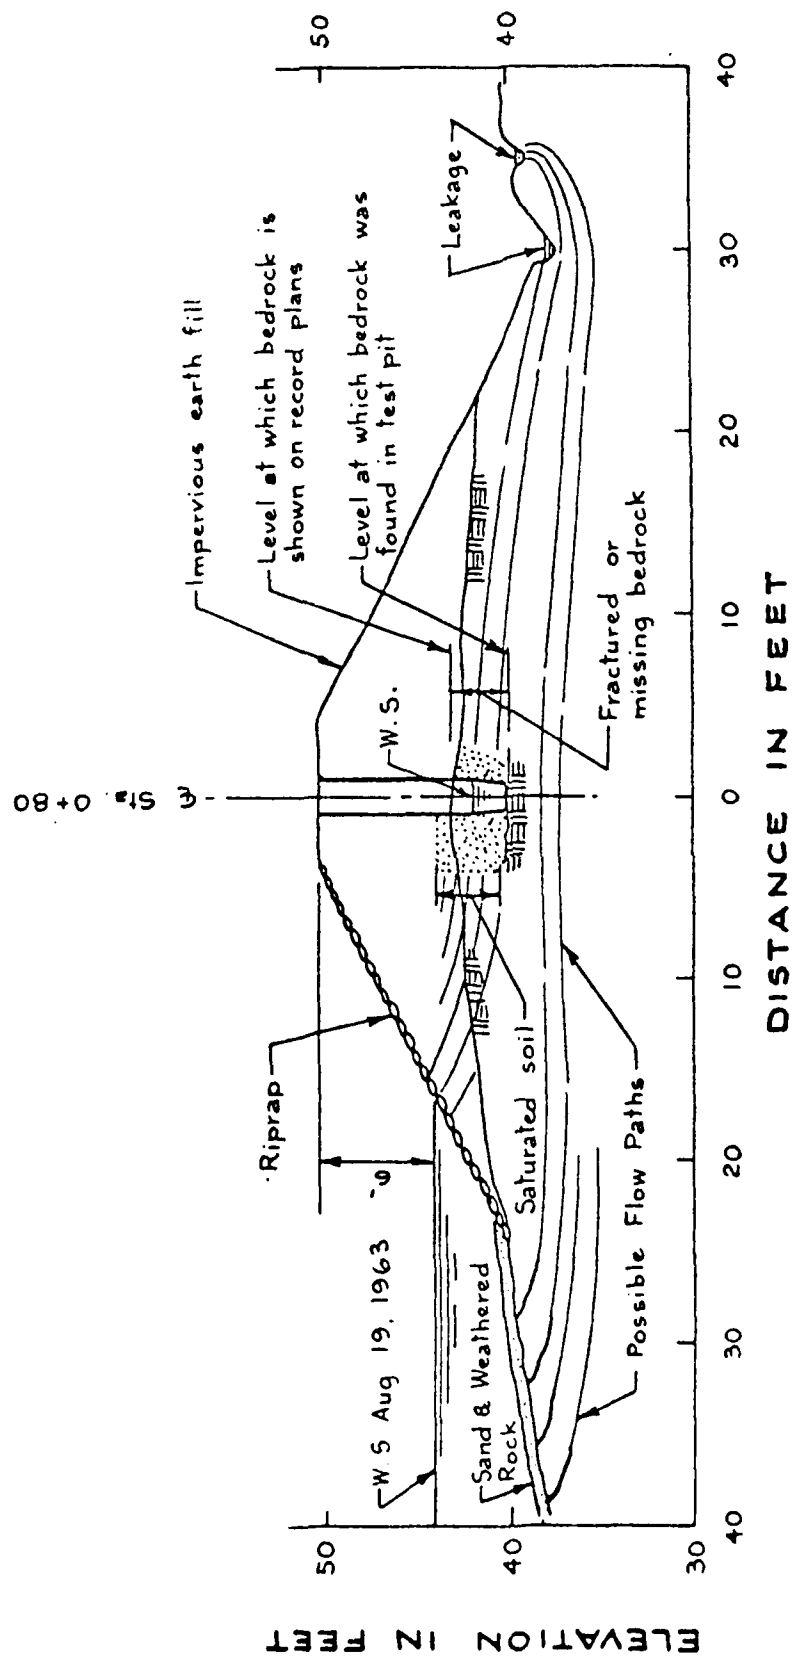
FIG.3 TEST PIT NO.3 - AUGUST 17, 1963

On August 17, 1963, Test Pit No. 2 was dug at Sta. 1+15, 10 ft East of the deflection point. The water level in the reservoir was 6 ft below the top of the dam on this date. At this location the earth fill rests directly on the granite corewall. Owing to the depth of the earth fill, the inadequate maneuvering area for the backhoe, and the limited space available atop the dam for storing the excavated material, the backhoe could not excavate deeper than about 9 ft. The hole was further deepened by hand, and the corewall sounded with an iron bar. The excavated material was uniform with a noticeable increase
